Leachate Damage Assessment: Case Study of the Sayville Solid Waste Disposal Site in Islip (Long Island), New York

EPA/530/SW-509
JUNE 1976

7. AUTHOR(S)
Kenneth A. Shuster

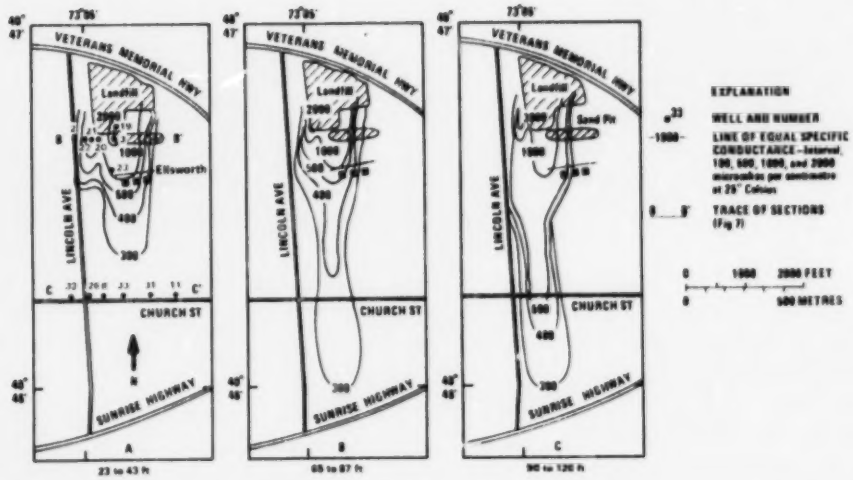
Leachate Characterization. The U.S. Geological Survey (U.S.G.S.) collected water samples over a three-year period (1972-74) from different depths at 30 monitoring well locations in order to describe the leachate plume. Using these data, various plots of the leachate plume were made using various leachate characteristics, such as specific conductance (Figures 5 and 6). Ambient water near the bottom of the aquifer has a specific conductance of less than 100 μmhos. The plume of the leachate-contaminated ground water extends about 5,000 feet from the site in the upper glacial aquifer. The worst, unpotable, ground water is near the disposal site. The plume moves as slugs of leachate, tending to sink toward the bottom of the aquifer, which is 170 feet below the water table. At 3,000 feet south of the site, the plume starts about 60 feet below the water table, and extends down to 150 feet below the water table.

Figure 5. Specific conductance of ground water in the upper glacial aquifer south of the Islip disposal site, in 1973, at the indicated depths below the water table. Source: Kimmel, G. E. and O. C. Braids. Preliminary findings of a leachate study on two landfills in Suffolk County, New York. Journal of Research of the U.S. Geological Survey, 3(3):273-280, May-June 1975.

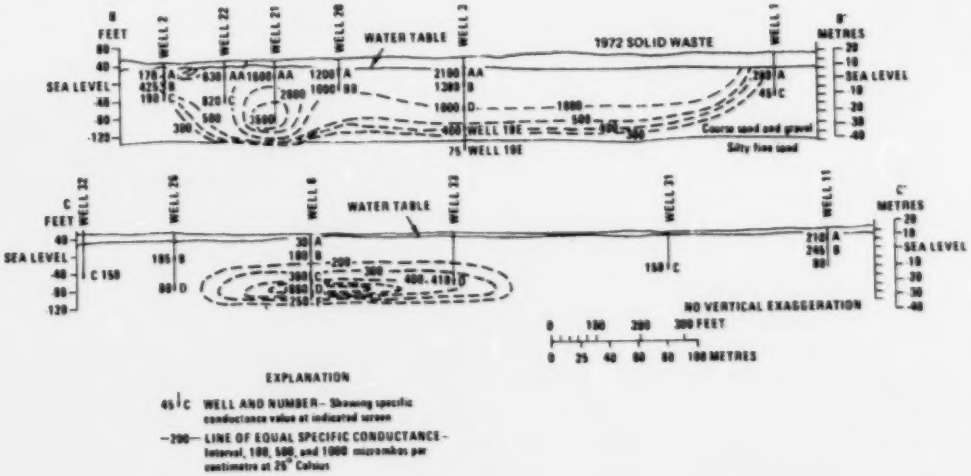
Figure 6. Specific conductance of ground water in the upper glacial aquifer south of the Islip disposal site (cross sections from Figure 5). Conductance for wells 1A, 1C and 3B in 1972; conductance for all wells in 1973. Source: Kimmel, G. E. and O. C. Braids. Preliminary findings of a leachate study on two landfills in Suffolk County, New York. Journal of Research of the U.S. Geological Survey, 3(3):273-280, May-June 1975.

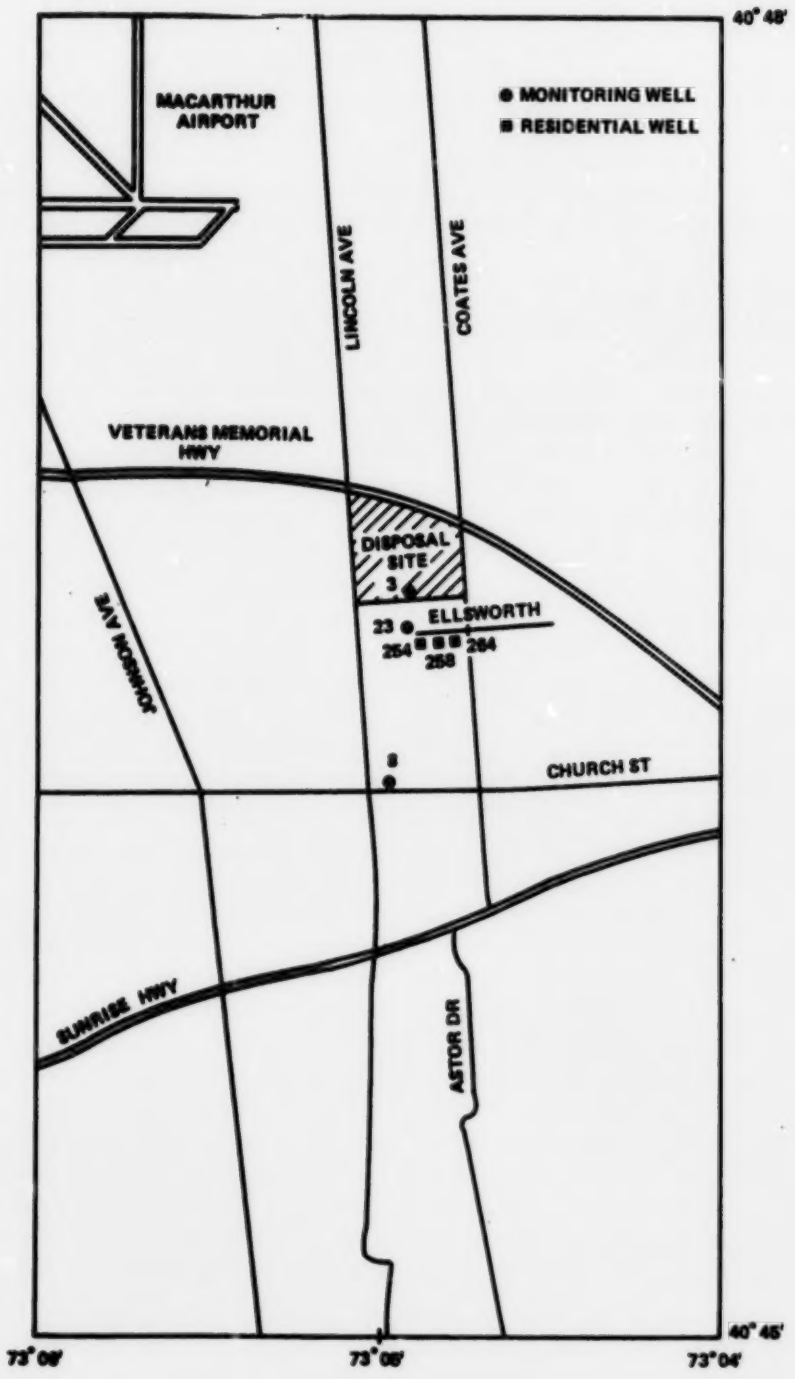
Only two well sample analyses of the contaminated wells were located (Table 3, Appendix). Monitoring well 8 is provided as essentially background to contrast cleaner ground water in the area with that of the affected wells at 264 and 258 Ellsworth. Monitoring well 23, at the end of Ellsworth Street, and monitoring well 3, on the disposal site perimeter and in line with 23, are provided to show additional leachate-contaminated ground water analyses in the vicinity of the individual residential wells (Figure 7).

Figure 7. Location of residential wells and monitoring wells.
